Milestone Inspection Report

KEG Project #22RS-0498
February 8th 2023
FINAL REPORT

Golden Strand Apartments, Inc.
109 The Esplanade South &
716 Grenada Blvd
Venice, FL 34285

RE: Golden Strand Apartments
109 The Esplanade South, Venice, FL 34285
KEG File# 22RS-0498
Professional Engineering Services – Milestone Inspection

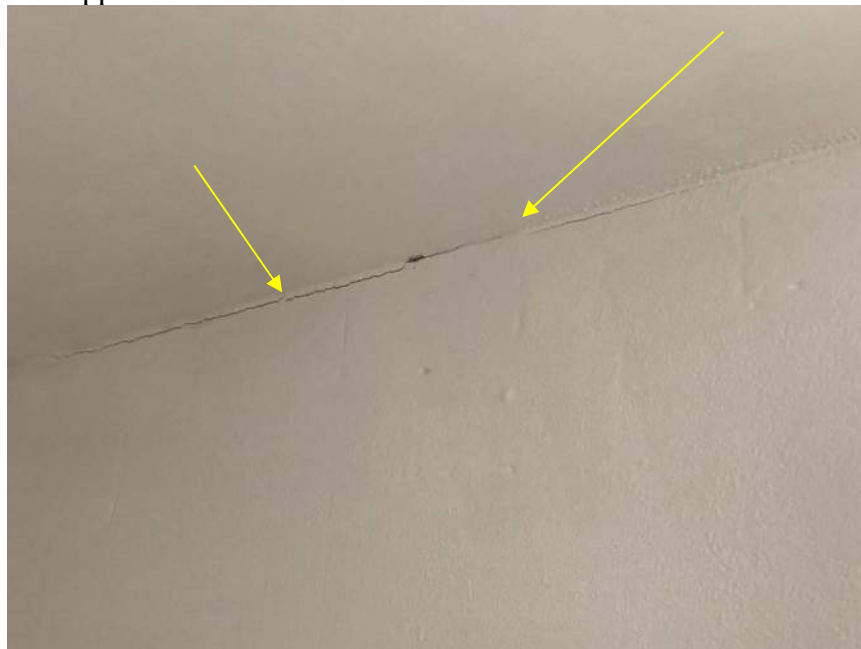
Hairline and fine cracks are visible in very few places at Golden Strand.

These hairline and fine cracks are of no structural concern and are considered shrinkage or movement cracks. Some cracks may be exterior finish or sealant related. See Appendix C.

Figure 16 Typical finecracks

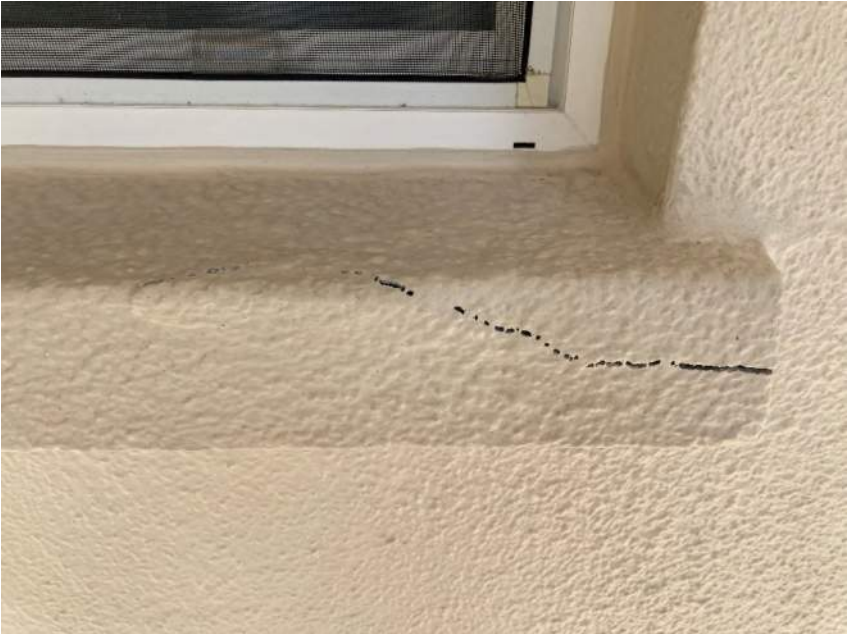
Medium and wide cracks were observed during our review at Golden Strand with respect to the window sills at Golden Strand.

Figure 17 One location of Window Sill cracking

1. Any future deteriorated concrete should be repaired in accordance with International Concrete Restoration Institute (ICRI) industry standards. Instances of cracking occur in Unit 403 of the Esplanade Building, in the stairwells of both buildings, and on one windowsill at the Granada Building.

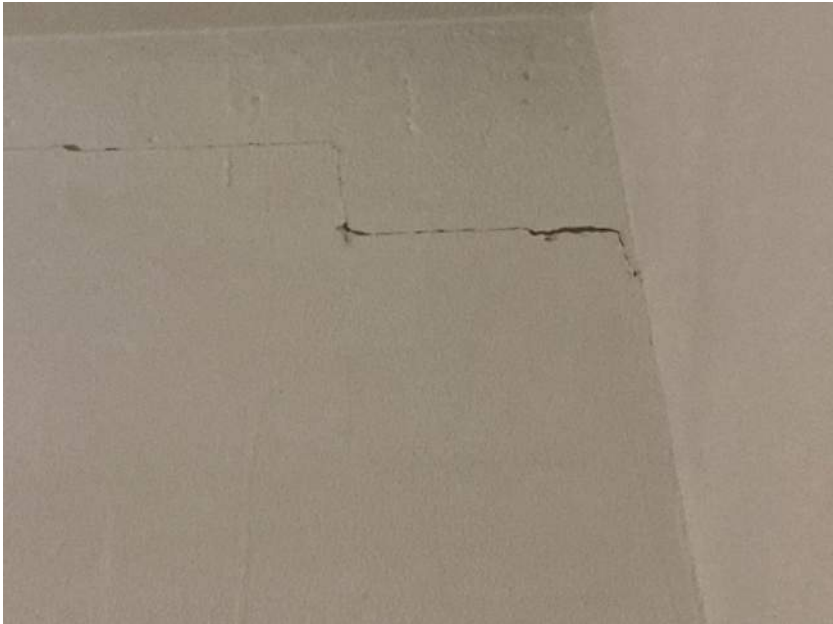
Figure 18 One location of Stairstepping

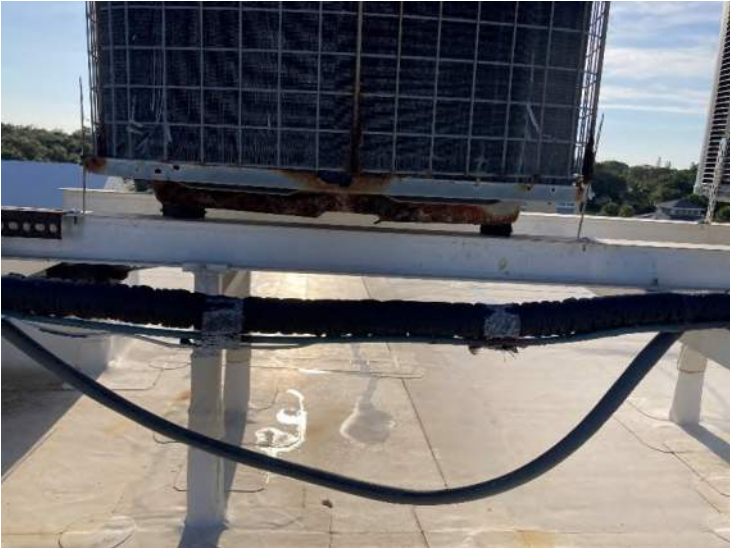
Corrosion of components like AC Units and outlets were evident, however.

Figure 22 corroding AC unit typical

3. Determine the efficacy of the AC components on the roof of both buildings. Many fasteners and brackets appeared to be rusted/corroded. If not taken care of, these units could detach from the stands on which they sit. In addition, general cleaning of the roof should take place, scrub coating, cleaning gutters of debris, etc.

- Replace all rusted AC unit connection brackets on roof. Also, consider elevating disconnect conduit off roof as it will rub against roof membrane in high wind events.

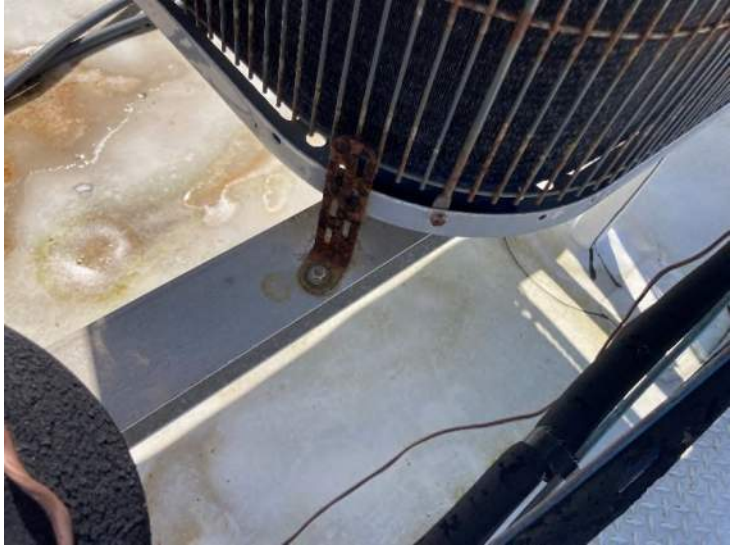
Figure 23 corroding AC unit bracket typical

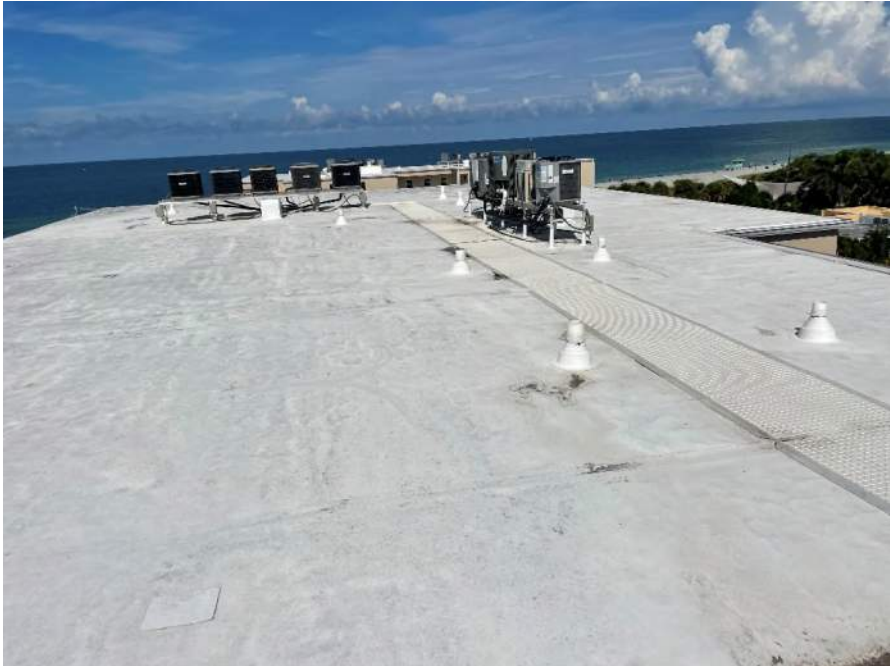
Figure 24 Flat roofing at Grenada Building

Overall, both roofs are in very good condition.

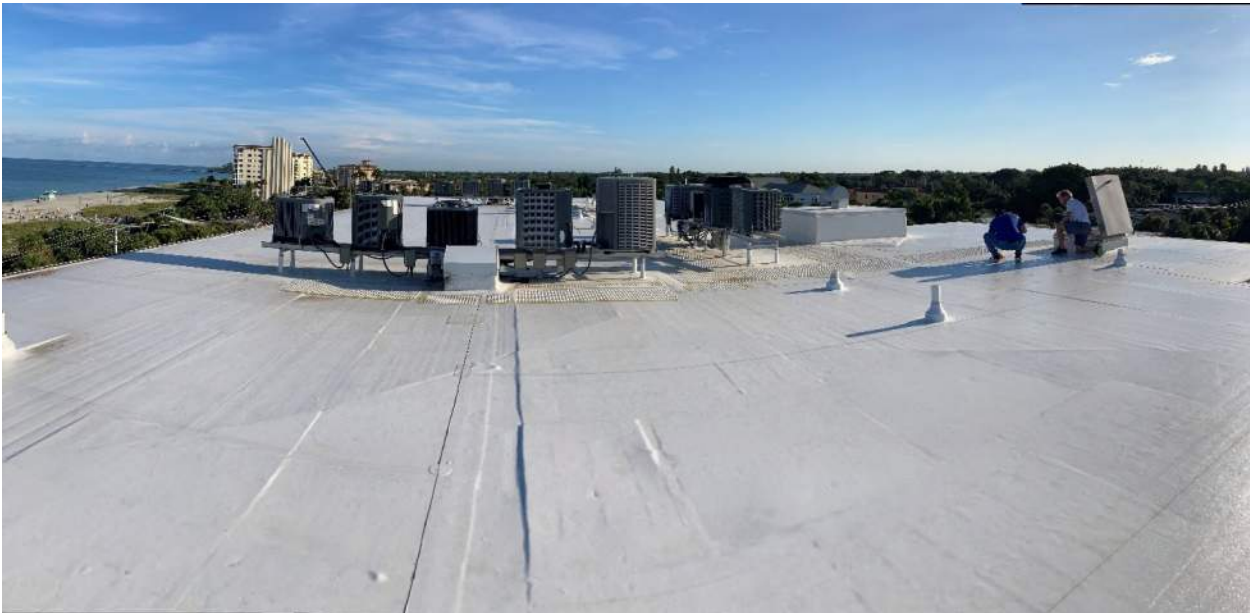
Figure 25 Flat roofing at Esplanade Building

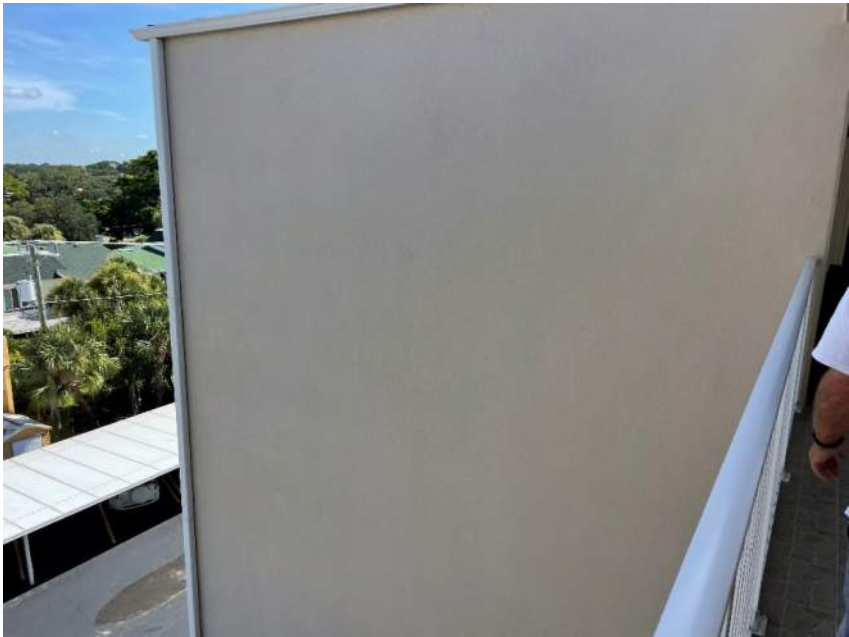
Figure 26. Paint at Golden Strand typical and in good condition

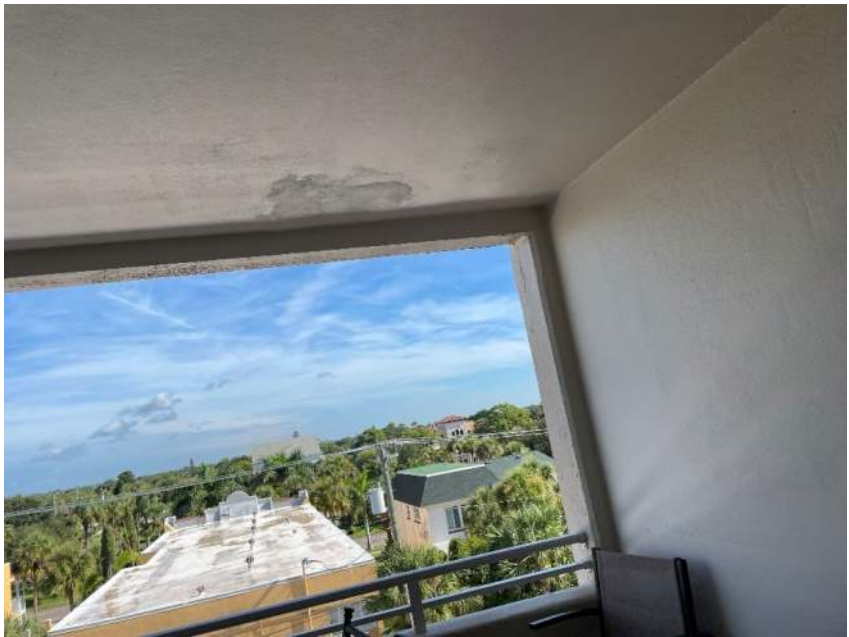
Figure 27. stucco previous repair noted

6. Inspect cracking in stucco around the property to determine if there are any structural issues.

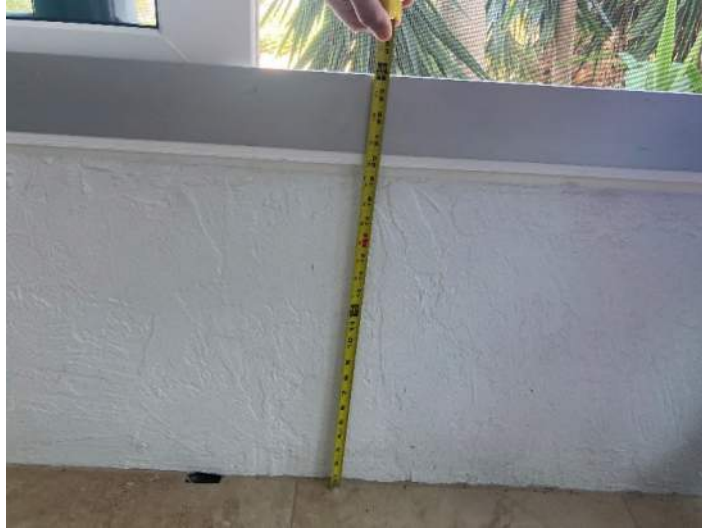
To Be Noted: A few units have windows that may or may not meet new building code for sill heights. Golden Strand to review code for compliance.

Figure 30 Windows sill height must be 24" if window is 6 ft above ground.

12. Life Safety – Reconcile the IRC and IBC as it relates to window openings with a sill height of less than 24 inches. Unit 204 in the Esplanade Building has a condition that could allow persons to fall over 72 inches as the window completely opens. Protection may be needed. See Unit 504 in the Granada Building.

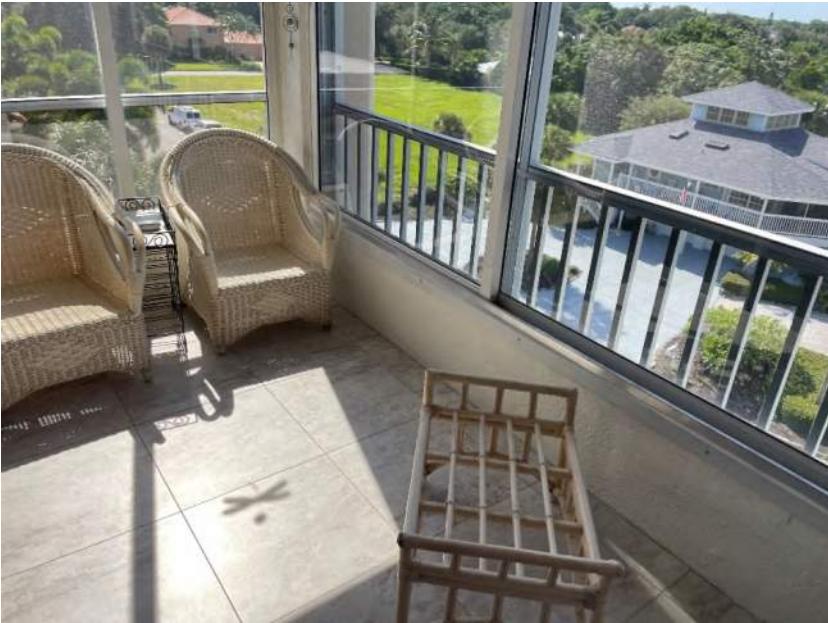
The tiles and grout are in fair condition with minor signs of cracked tiles and efflorescence on grout. Stains on tiles indicate ponding of water and should be remediated by thorough cleaning. Efflorescence should be cleaned but does not compromise the integrity of the tiles.

Figure 32 Typical Tiled Balcony at Golden Strand with railing enclosure on outside

7. KEG recommends the following for the balconies:
 - Clean the grout and tiles of all balconies.
 - Keep at a distance of at least one foot between planters and any wall to avoid premature paint damage.

- Remove and replace areas of hollow tiles.
 - Clean or reinstall any missing fasteners in tracks or frames of windows, doors, or screens. No instances of missing fasteners were noted at the time of the survey.
